APPENDIX E

- **Proposed Sanitary Landfill
Plates 1 to 9**

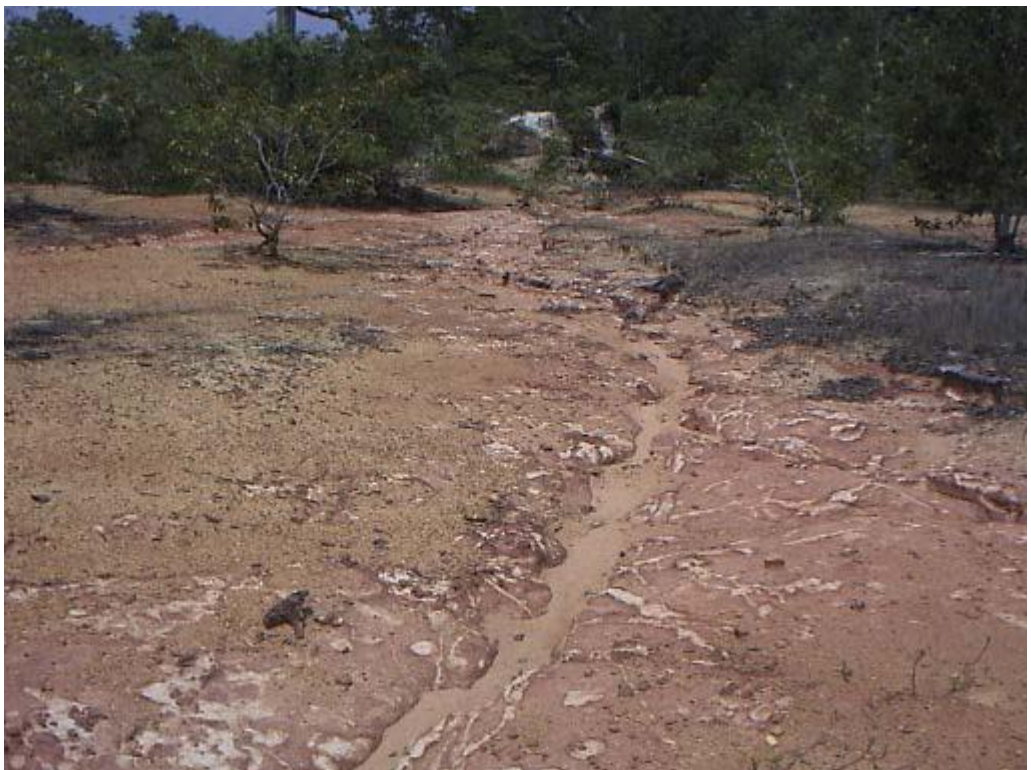
Plate 2: Typical erosion channel running along slope of ridge. Frame shows effect of erosion on exposed ground. These channels are along the southern slope.

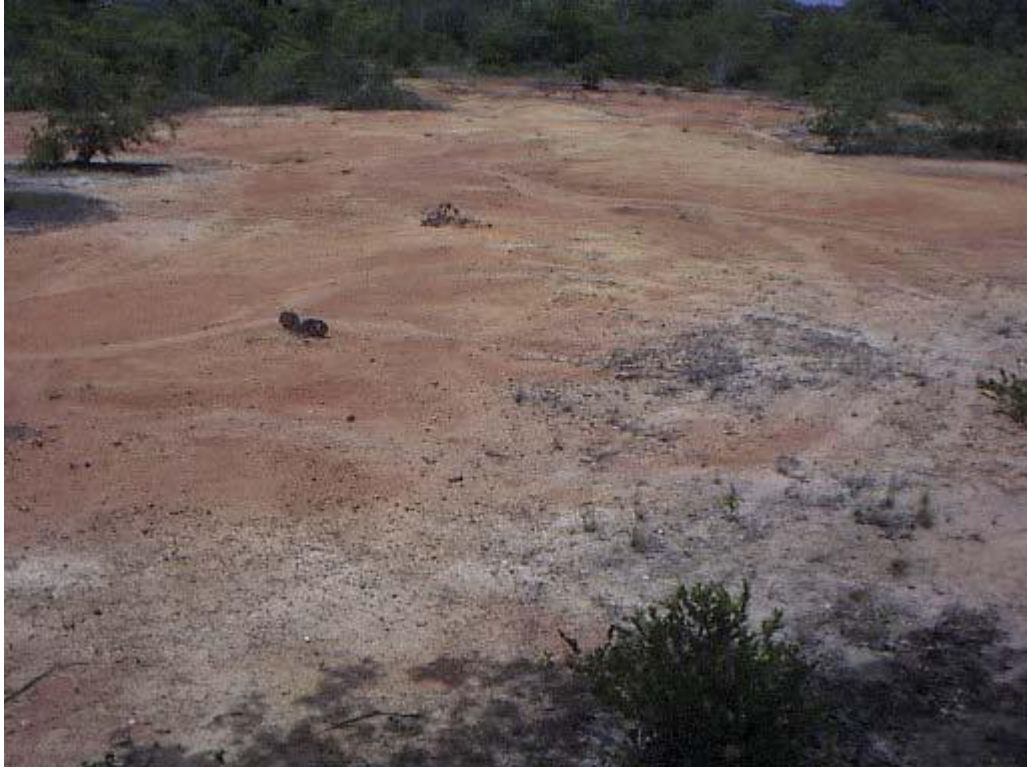
Plate 3: Denuded landscape along portions of the western slope.

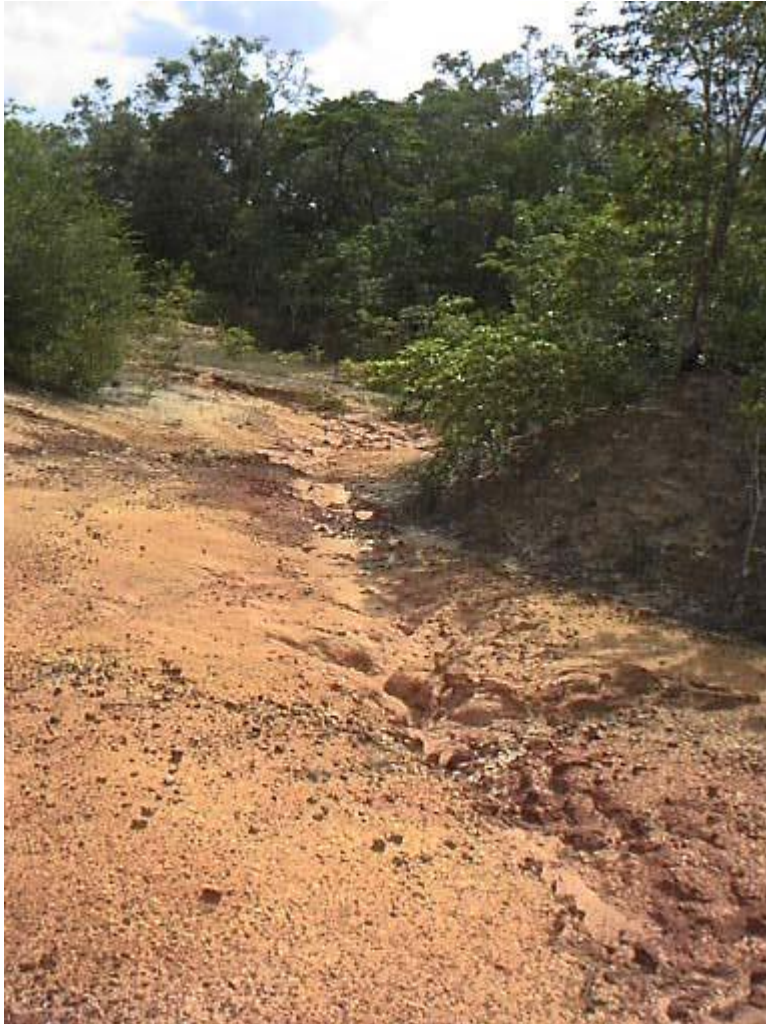
Plate 4: Disturbed landscape along portions of the eastern slope.

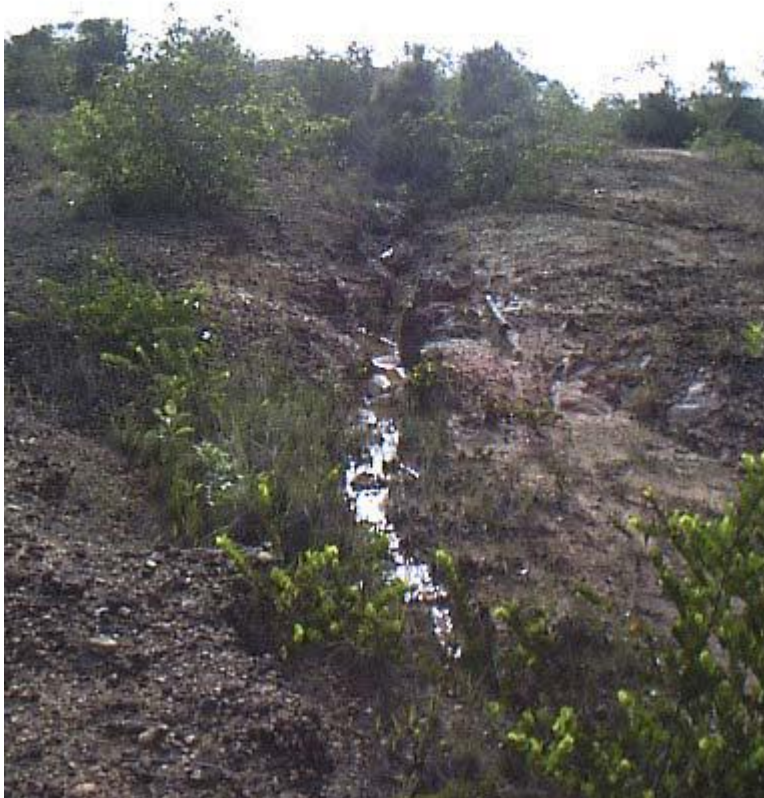
Plate 9. Deep erosion channels draining into seasonal streams along southern slope. Note sparse vegetation.
